Safety Communication

Broken circlip on Hanaulux sterilizable handle hub

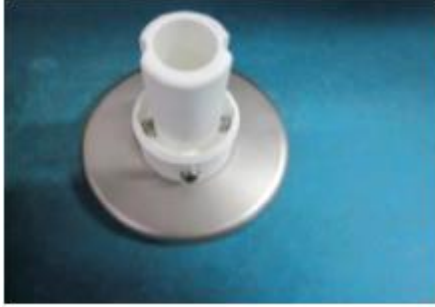
<p style="text-align: center;">Hanaulux Hub</p>

<p>Recommendation/ Actions:</p>	<ol style="list-style-type: none"> 1. Review this notice and ensure that affected personnel are aware of the contents. 2. Verify that the locking mechanism works correctly before use. 3. If you have affected product at your facility, or if the mechanism does not work or lock correctly, contact the authorized representative to arrange for the correction of your device. 4. Only use the recommended cleaning materials and cleaning protocols <p>For more information, Please click here.</p>	
<p>Devices/Products photo:</p>

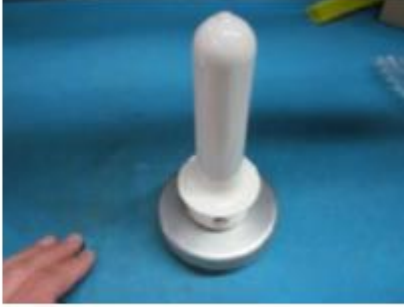
<p style="text-align: center;">Hub with sterilizable Handle</p>
<p>Authorized Representative Details</p>	<p>AR name:</p>	<p>Gulf Medical Co.</p>
	<p>Assigned Contact Person:</p>	<p>Mohammed Al Ghamdi</p>
	<p>Mobile/Phone:</p>	<p>0551417735</p>
	<p>Email:</p>	<p>regulatory@gulfmedical.com</p>
